CALSPAN ON-SITE AMBULANCE CRASH INVESTIGATION

SCI CASE NO: CA09082

VEHICLE: 2004 FREIGHTLINER 2500 SHC / MEDIX TYPE II AMBULANCE

CRASH DATE: OCTOBER 2009

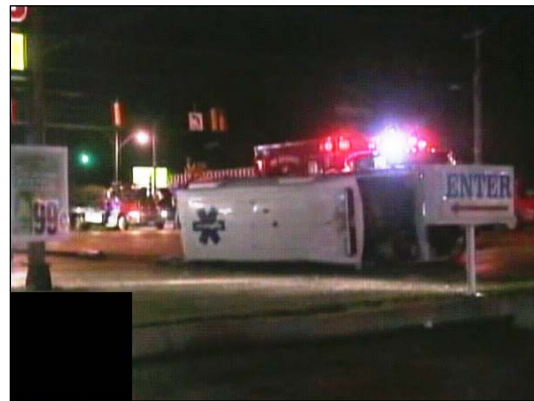
The combination of the wheel engagement and the rearward location of the impact in relation to the vehicle's center of gravity induced a counterclockwise (CCW) rotation to the Freightliner. As the vehicles separated, the Freightliner continued to rotate CCW on the asphalt road surface as it maintained its northbound trajectory. The Freightliner traveled approximately 20 m (66 ft) in a northerly direction and rotated approximately 38 degrees CCW. The rotation, coupled with the vehicle's high center of gravity, resulted in a turn-over rollover event. The vehicle rolled onto its right side as its center of gravity continued in a northerly direction for a distance of 9 m (30 ft). The rollover event was classified "interrupted" as the top right rear corner area of the Freightliner impacted the utility pole. This event arrested the continued CCW rotation of the Freightliner and redirected the vehicle's heading angle to a northerly direction. The Freightliner slid another 35 m (115 ft) on its right side prior to coming to rest at the mouth of a driveway at the east road edge. The total distance traveled from the point of rollover to final rest was approximately 44 m (144 ft). **Figure 7** is an on-scene image to the ambulance at final rest.

Figure 7: On-scene image of the Freightliner ambulance at final rest. (*Local news agency image*)

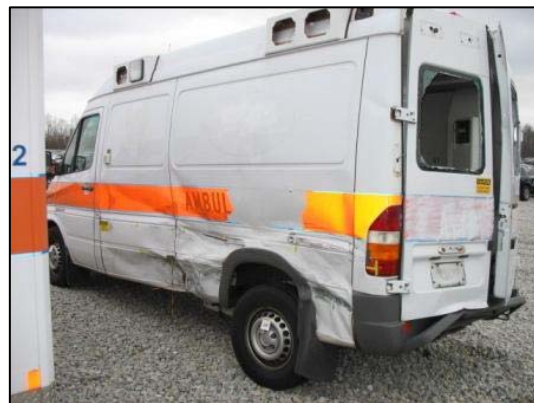
The left side of the ambulance sustained moderate severity damage from the initial impact event with the Dodge. Maximum crush was 14 cm (5.5 in), located 19 cm (7.5 in) aft of the left C-pillar. The direct contact damage began 150 cm (59 in) aft of the left front axle and extended 259 cm (102 in) to the left taillight location. The combined direct and induced damage (Field L) began 128 cm (50.5 in) aft of the left front axle and extended 329 cm (130 in) to the left taillight. The residual crush measured along the left side at mid-door level was as follows: C1 = 0 cm, C2 = 7 cm (3 in), C3 = 10 cm (4 in), C4 = 11 cm (4.5 in), C5 = 5 cm (2 in) and C6 = 0 cm. The sill height measured 41 cm (16 in). A second profile was documented at the level of the sill At C-locations C4-C6. These values were as follows: C4 = 12 cm (4.5 in), C5 = 6 cm (2.5 in) and C6 = 0 cm. The sill C values at C1 to C3 fell outboard of the sill within and aft of the wheel opening. There was no crush at the door/sill level; therefore, the Door Sill Differential was 0 cm.

The leading edge of the left rear tire of the Freightliner engaged the corner of the Dodge's front bumper. This impact dented the outer bead of the wheel 10 x 1 cm (4 x 0.4 in) and displaced the axle rearward. The left wheelbase was lengthened by 14 cm (5.5 in) to 370 cm (145.5 in). The Collision Deformation Classification (CDC) associated

Figure 8: Left side impact damage to the Freightliner ambulance.

with the side impact event was 11LZEW3. The side impact damage profile is depicted in **Figure 8**.

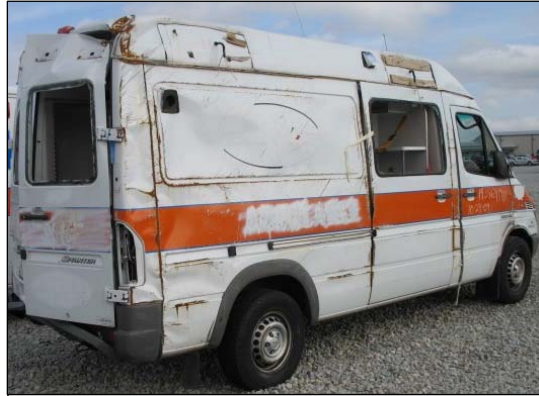
The direct contact damage from the one-quarter turn rollover event was distributed across the entire right plane of the ambulance, longitudinally and vertically. The damage consisted of surface abrasions with isolated dents to the rear quarter panel area of the vehicle (**Figure 9**). The direct damage began 36 cm (14 in) forward of the right front axle and extended 498 cm (196 in) to the right rear corner. Vertically, the damage began 57 cm (22.5 in) above the ground and extended 204 cm (80.5 in) to the top of the roof panel. The right front door glazing was closed at the time of the crash and was disintegrated by the outside mirror as it was displaced into the glazing during the rollover event. The sliding door glazing was fixed within the frame and was disintegrated during the rollover event. The CDC associated with the one-quarter turn rollover event was 00RDAO3.

Figure 9: Right side rollover damage to the Freightliner ambulance.

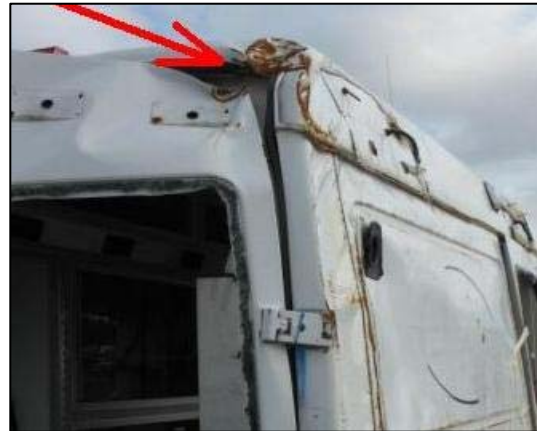
The damage from the non-breakaway pole impact event (Event 3) was located at the top rear corner area of the ambulance (**Figure 10**). The direct contact damage was 13 cm (5 in) in width that began at the right rear corner and extending inboard along the back header and the upper aspect of the right rear door. Vertical crush of 6 cm (2.5 in) was located at the center of the direct damage on the back header. The CDC associated with this event was 00TBRN2.

Figure 10: Pole impact damage to the top right corner of the roof of the Freightliner ambulance.

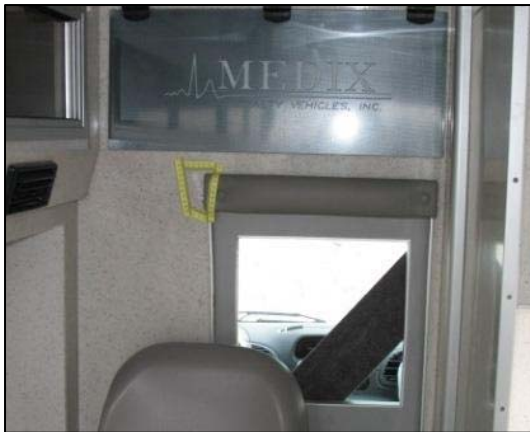
Figure 11: EMT head impact to the forward wall of the patient compartment.

initial left side impact by moving laterally to his right and forward with respect to his seating position. Due to his unrestrained status, the passenger was displaced from the bench seat and traveled across the interior of the patient compartment. His lower extremities probably contacted the cot and/or the patient. During this trajectory, the ambulance rotated CCW direction by the crash. The passenger moved left and forward with respect to the interior and impacted the stack of compartments and the Captain's Chair at the forward left quadrant of the patient compartment. His head impacted the rigid wall above the Captain's Chair. The composite wall was fractured adjacent to the foam padding. This contact resulted in the laceration of his occipital scalp.

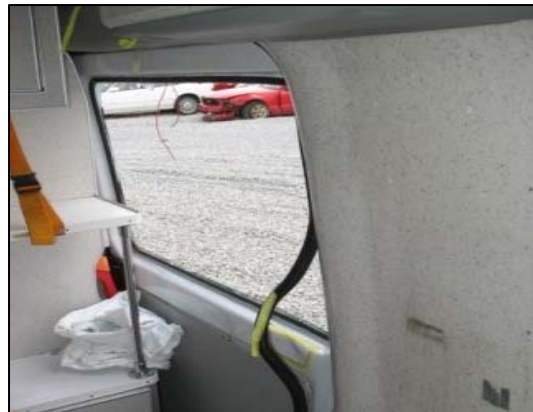
Figure 12: Right sliding access door contacts within the Freightliner ambulance.

The passenger's right shoulder probably contacted the padded area above the right side sliding door. This padded surface was scuffed and abraded. He sustained a right clavicle fracture that was probably attributed to this contact.

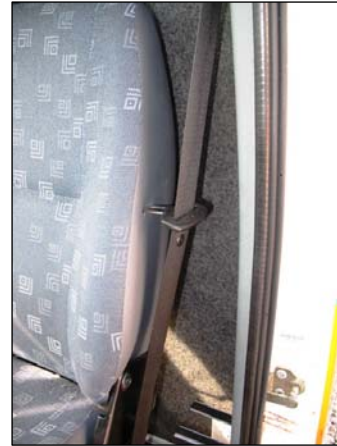
not restrained by the manual safety belt at the time of the crash. The front right seat was unoccupied, however, the retractor pretensioner actuated, cinching the belt webbing taut against the pillar.

Figure 13: Taut driver safety belt.

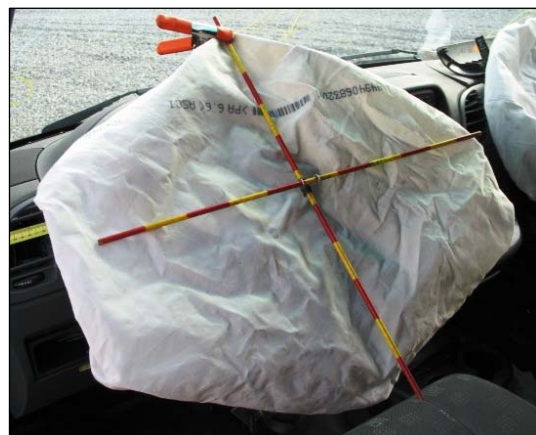
The steering wheel hub-mounted driver air bag pictured in **Figure 14** was identified by the manufacturer's code 449406832601. It was constructed of Automotive Safety Components International (ASCI) recognized PA 6.6 nylon material. The driver air bag had properly deployed through its three designated flaps in the face of the 4-spoke steering wheel, without damage. The air bag was 62 cm (24.5 in) in diameter in its deflated stated and was not tethered or vented. Maximum rearward excursion from the center hub measured 53 cm (21 in). There was no evidence of occupant contact found on the bag at the time of SCI inspection.

Figure 14: Deployed driver air bag in the Freightliner ambulance.

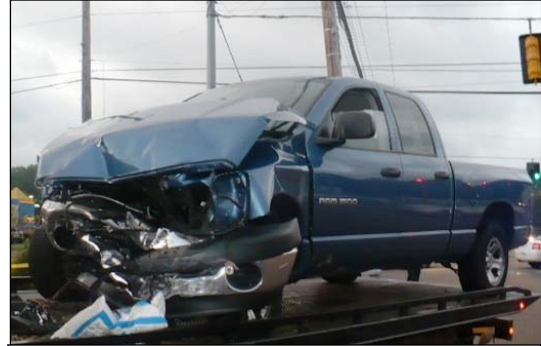
Based on the on-scene photographs provided by the parent ambulance company, such as **Figure 14**, the front end of the Dodge sustained disabling damage from the crash. There was longitudinal crush to the bumper, grille, hood, and fender, and both headlight assemblies were disintegrated. There was significant damage to under hood components as well, as the radiator and fluid reservoirs were crushed rearward. There also appeared to be left lateral shift of front end

Figure 14: Damage sustained by the Dodge.
(Image courtesy of the ambulance company)

components, including the bumper and both fenders. Direct contact damage extended from bumper corner to bumper corner. Maximum crush to the front of the Dodge was near the center, biased to the right side. For reconstruction purposes, a crush profile was estimated based on SCI experience and available photographs. The corresponding estimated crush profile was as follows: C1 = 12 cm (5 in) , C2 = 18 cm (7 in), C3 = 33 cm (10 in), C4 = 45 cm (13 in), C5 = 30 cm (12 in) and C6 = 25 cm (10 in). Noting vehicle end shift based on visible damage and impact configuration, the CDC associated with the impact event was 82FDEW2.
